# SWIVEL SNAPHOOK INSPECTION NOTIFICATION

**Inspection notice for GFP products featuring a possible unsafe condition due to a supplier defect in a specific style of swivel snaphook supplied to Guardian between 8/26/2011 and 6/25/2012**

Date: 6/26/2012

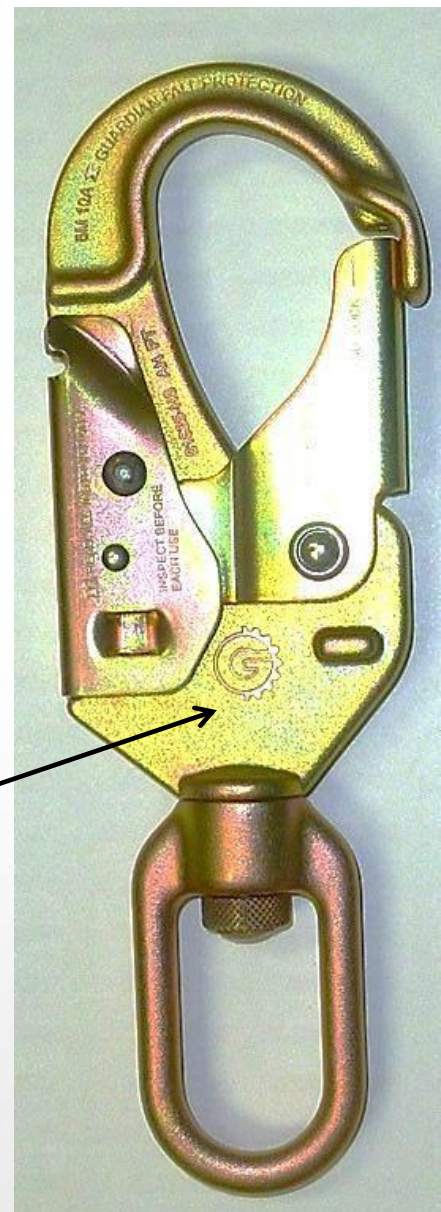
Full photo of the potentially defective swivel snaphook.
